17569, 17570, 17571, 17572, 17573

CURVED TILE ROOF HOOK FOR SIDE MOUNT RAILS; ADJUSTABLE

Subject: QS# 17569 – All Tile Roof Hook 90° Laboratory Load Testing

Subject: Uplift, Compressive Load, and Lateral Load Test of QS #17569 (Kit #17571) 90° Spanish Tile Roof Hook with Slots, 5 mm Height Adjustment Range

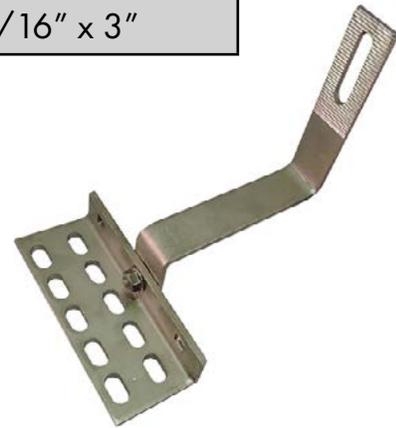
Letter	Description	Size/Length
A	Mounting Screw Slot	9mm x 18mm
B	Rail Slot Size	10mm x 46mm
C	Length of Roof Hook	179.5mm
D	Bottom End to Top End	165.90mm - 173.50mm
E	Thickness	6mm
F	Adjustability Range	42mm - 50mm

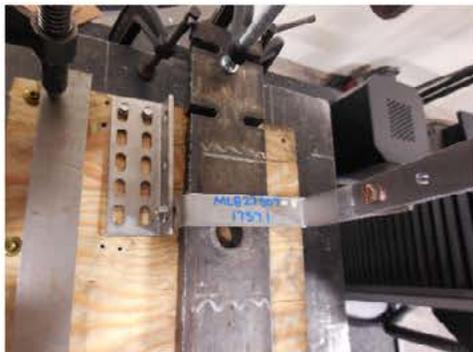
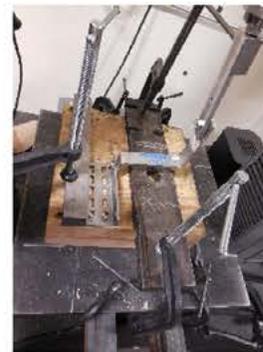
Photo 1: Tensile Test Setup

Photo 2: Tensile Test Setup

A total of two tests were conducted for tensile load (uplift) capacity on an Instron Universal Test Machine (UTM). The test samples were rigidly attached to the test machine using clamps and a tensile load was applied to the roof hook. The tensile load was applied at a constant rate of 0.09 in./min. without shock until failure. The load and displacement at failure were recorded and the failure mode was documented in photos. The average tensile load of the 90° Spanish Tile Roof Hook with Slots and 5 mm Height Adjustment Range attached to the 2"x4" using the #14 x 3" Solar Mounting screws was 1382 lbf. Additional details and photographs are supplied on page 3.

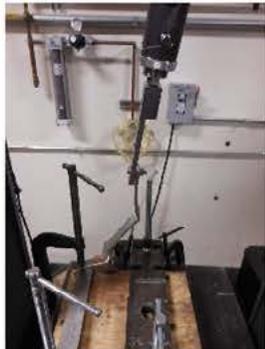
Photo 3: Typical Failure Mode - Fastener Pullout

#14 x 3" Solar Mounting Screws	
FASTENER LOCATION:		Fasteners (Qty 2) installed in furthest slot point and secured to 2 x 4 running underneath plywood.			
TENSILE LOAD (UPLIFT) TEST DATA					
NO.	MAXIMUM LOAD (lbf)	DISPLACEMENT AT LOAD (in.)	OBSERVATIONS		
1	1498.0	6.733	Fastener pullout, fastener head failure, and permanent deformation failure.		
2	1266.7	6.858	Fastener pullout, fastener head failure, and permanent deformation failure.		
AVG.	1382.4	6.796

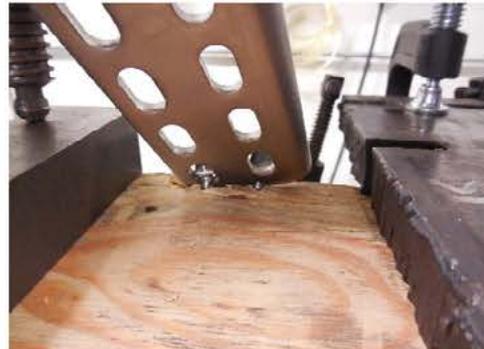
Photo 4: Closeup of Fastener Pullout & Failure

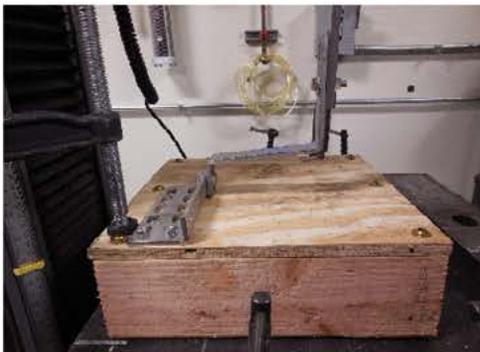
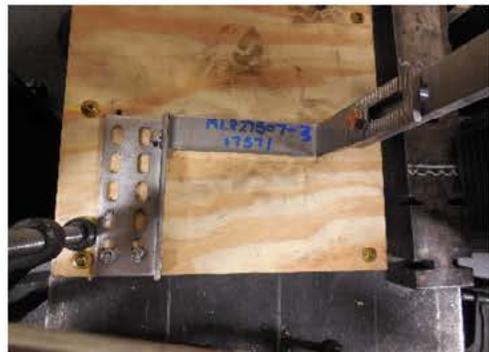
Photo 5: Compression Test Setup

Photo 6: Compression Test Setup

A total of two tests were conducted for compressive load capacity on a UTM. The test samples were rigidly attached to the test machine using clamps and a compressive load was applied to the roof hook. The compressive load was applied at a constant rate of 0.09 in./min. without shock until the roof hook came into contact with the plywood base. The load and displacement at contact were recorded and the failure mode was documented in photos. The average compressive load of the 90°

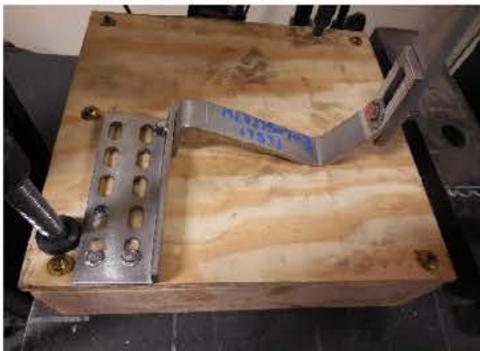
Photo 7: Hook Contact with Plywood

CLIENT		CLIENT PROJECT REF. NO.		CLIENT ORDER NO.	
SolarRoofHook		17568, 17569, 17570, 17571		Per S.A.	
SAMPLE DESCRIPTION			ROOF HOOK ID		PRODUCT KIT ID
90° Spanish Tile Roof Hook w/ Slots, 5 mm Height Adj.			17568, 17569		17570, 17571
MATERIAL SUBMITTED BY		PNL PROJECT NO.	S.O. NO.	PNL LAB NO.	REPORT DATE
Client		26-170169	001	ML827507	04/13/2017
TEST SPECIFICATIONS & EQUIPMENT INFORMATION					
TEMPERATURE:		73° ± 3°F		HUMIDITY:	
EQUIPMENT MODEL:		Instron 5985		SERIAL NO:	
LOAD CELL:		10 kN (2,248 lbf)		SERIAL NO:	
TEST SPEED:		0.09 in./min.		FASTENER TYPE:	
FASTENER LOCATION:		Fasteners (Qty 2) installed in furthest slot point and secured to 2 x 4 running underneath plywood.			
COMPRESSION LOAD TEST DATA					
NO.	MAXIMUM LOAD (lbf)	DISPLACEMENT AT LOAD (in.)	OBSERVATIONS		
3	324.4	2.434	Test Hook permanently deformed and came into contact with plywood base		
4	334.3	2.431	Test Hook permanently deformed and came into contact with plywood base.

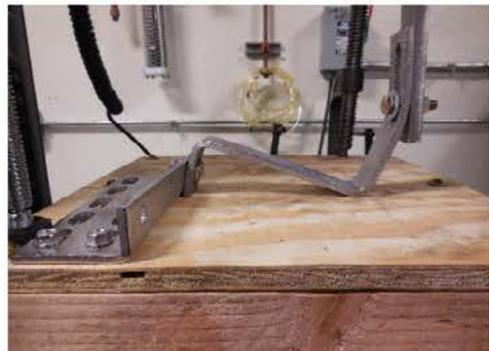
Photo 8: Typical Failure - Contact with Plywood

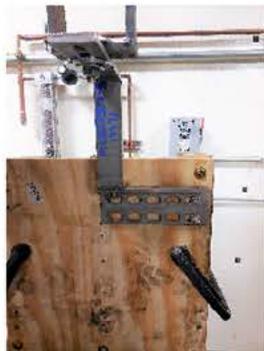
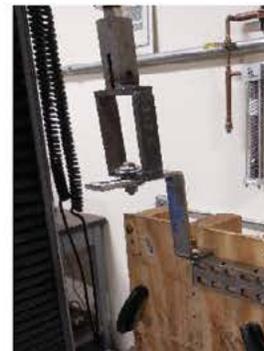
Photo 9: Shear Test Setup

Photo 10: Shear Test Setup

A total of two tests were conducted for shear load (lateral load) capacity on a UTM. The test samples were rigidly attached to the test machine using clamps so that a compressive load could be applied to the roof hook in a direction parallel to the 2"x4" rafters. The shear load was applied at a constant rate of 0.09 in./min. without shock until the roof hook until failure. The load and displacement at tact were recorded and the failure mode was documented in photos. The average compressive load of the 90° Spanish Tile Roof Hook with Slots and 5 mm Height Adjustment Range attached to the 2"x4" using the #14 x 3" Solar Mounting screws was 483 lbf. Additional details and photographs are supplied on page 5.

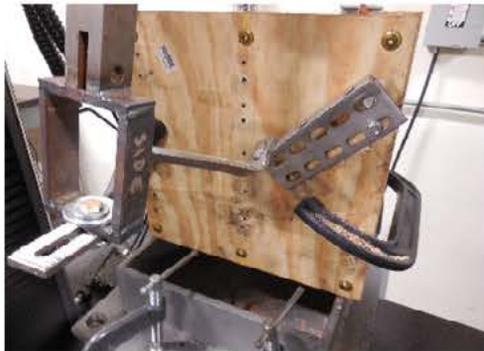
Photo 11: Deformation and Rotation of Hook

CLIENT		CLIENT PROJECT REF. NO.		CLIENT ORDER NO.	
SolarRoofHook		17568, 17569, 17570, 17571		Per S.A.	
SAMPLE DESCRIPTION			ROOF HOOK ID		PRODUCT KIT ID
90° Spanish Tile Roof Hook w/ Slots, 5 mm Height Adj.			17568, 17569		17570, 17571
MATERIAL SUBMITTED BY		PNL PROJECT NO.	S.O. NO.	PNL LAB NO.	REPORT DATE
Client		26-170169	001	ML827507	04/13/2017
TEST SPECIFICATIONS & EQUIPMENT INFORMATION					
TEMPERATURE:		73° ± 3°F		HUMIDITY:	
EQUIPMENT MODEL:		Instron 5985		SERIAL NO:	
LOAD CELL:		10 kN (2,248 lbf)		SERIAL NO:	
TEST SPEED:		0.09 in./min.		FASTENER TYPE:	
FASTENER LOCATION:		Fasteners (Qty 2) installed in furthest slot point and secured to 2 x 4 running underneath plywood			
SHEAR LOAD TEST DATA					
NO.	MAXIMUM LOAD (lbf)	DISPLACEMENT AT LOAD (in.)	OBSERVATIONS		
5	506.7	6.461	Permanent deformation of roof hook and screws. Base of roof hook digging into plywood.		
6	459.8	7.364	Permanent deformation of roof hook and screws. Base of roof hook digging into plywood.

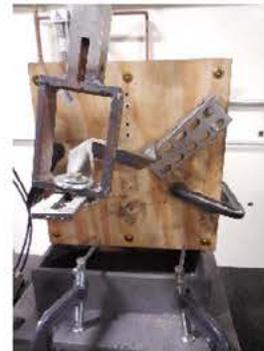
Photo 12: Typical Failure Mode - Deformation

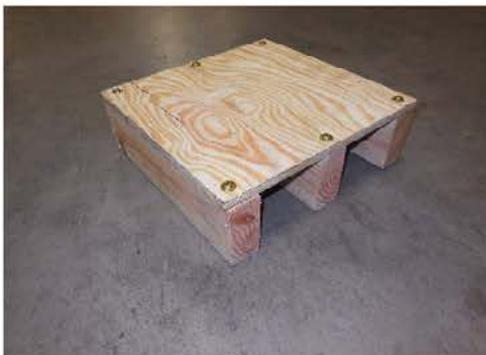
The base for the test assemblies was made from three 12 in. long Douglas Fir 2"x4"s screwed to 12 mm Birch plywood using 5/16" x 3-1/8" RSS Rugged Structural screws. The Roof Hooks were then attached using two of the Client provided #14 x 3" Solar Mounting Screws. On roof hooks that had multiple mounting screw slots, the screws were set at the furthest end of the furthest slot from the 90° section of the roof hook. The mounting screws were screwed through the plywood and into a 2"x4" underneath. On adjustable roof hooks, the 90° roof hook attachment was connected at one extreme end and the mounting screws were attached in screw slots at the opposite end.

Photo 13: Test Mockup Base Assembly

Each roof hook was attached to a Douglas Fir 2"x4" using two #14 x 3" Solar Mounting Screws. The 2"x4" rafter and plywood test fixtures were assembled in our laboratory by using 5/16" x 3-1/8" RSS Rugged Structural screws to connect three 12 in. long 2"x4" douglas fir rafters to the 12 mm Birch plywood. Each 2"x4" rafter was connected to the plywood using two screws at each end of the 12 in. long 2"x4" (See Page 6 for photos and details).

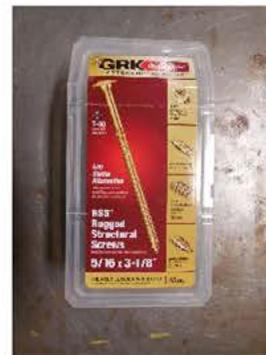
Photo 14: Fasteners for Plywood to 2x4: 5/16 x 3-1/8" RSS Rugged Structural Screws

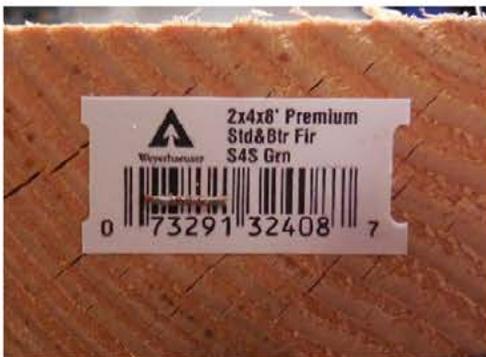
Photo 15: Douglas Fir 2x4 Product Tag

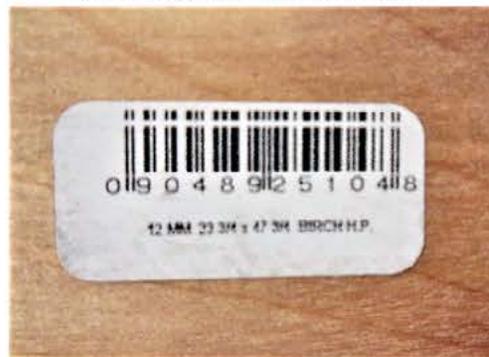
Photo 16: Birch Plywood Product Tag
